TECHNICAL SUMMARY

Preventing Stripping of Asphalt Pavements under Chip Seals

This Technical Summary pertains to LRRB-produced Report 2013-08, "Stripping of Hot-Mix Asphalt Pavements under Chip Seals," published April 2013. The full report can be accessed at <http://www.lrrb.org/PDF/201308.pdf>.

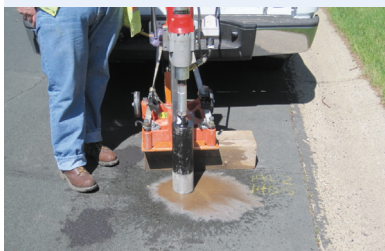
Researchers took core samples of city streets for air void and permeability testing in the laboratory.

After testing laboratory samples, researchers conducted similar testing on core samples taken from city streets experiencing stripping. They also developed field test requirements for using a field permeameter and nuclear density gauge—which determines density by measuring reflected radiation—to evaluate whether a street is a good candidate for a chip seal and will be less likely to strip.

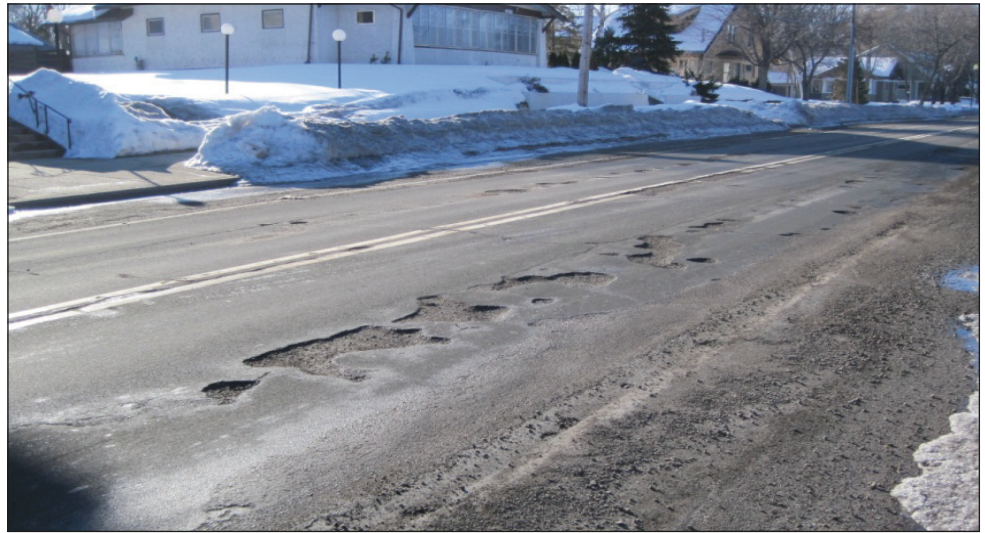
Stripping tends to occur under chip seals of urban curb-and-gutter streets because their closed structure traps water, which can damage asphalt where density is low. Results showed that using a more breathable fog seal instead of a heavier chip seal may help alleviate this problem.

Results also showed that alternative use of a lighter fog seal could help alleviate stripping by stopping water infiltration while allowing water vapor to escape.
